Safety Standard's Failure to Reveal Defects In Police Vehicle's Fuel System Crashworthiness

M W Arndt*

*Transportation Safety Technologies, Inc, Mesa, AZ, USA

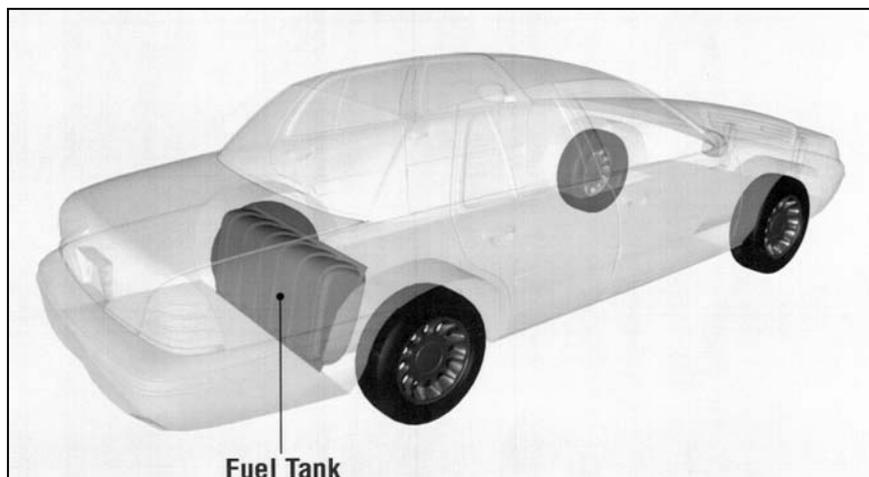
Figure 1, CVPI Vertical-Behind-The-Axle Fuel Tank

The vehicles described in this manuscript include the 1992 to present Ford Crown Victoria Police Interceptor (CVPI). The vehicle, although represented to be specifically designed, engineered and equipped for police use, is identical to the civilian-use Ford Crown Victoria except for minor upgrades to the vehicle handling, larger engine and installed police equipment. The fuel containment system, in this particular design, orientates the fuel tank vertically, located immediately to the rear of the rear axle and suspension, and immediately forward of a deep well trunk as illustrated in Figure 1.

The consistent performance of the CVPI fuel tank in failure producing high speed rear impact involves crushing of the fuel tank. Crash caused forward deformation induces contact to the back of the fuel tank which in turn moves the fuel tank forward causing contact to the front of the fuel tank by the axle/differential assembly. The fuel tank gets caught between these two relatively rigid structures

and is crushed. Sharp objects on the axle/differential assembly puncture the front of the fuel tank. Sharp objects in the trunk of the CVPI and sharp protrusion from deformed aft vehicle structures puncture the rear of the fuel tank. Finally, because localized crush induces deformations to the fuel tank failures at various tank closures occur. The tank closures that fail include valves located across the top of the fuel tank, the filler neck to fuel tank seal and the fuel tank sender unit.

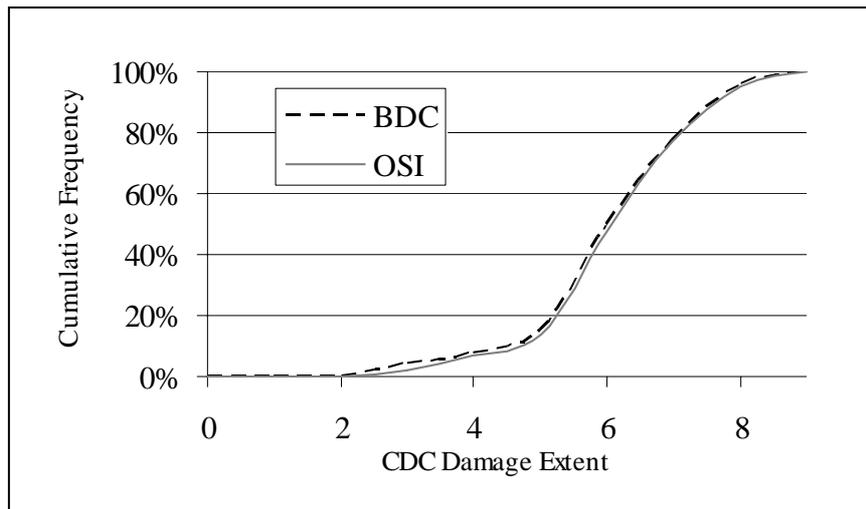
Figure 2, Cumulative Frequency of known CDC Damage Extent

Coding of the CDC for each crash provides the basis for the filter that identifies the BDC population. Specifically, crashes that have a five, six and seven o'clock principal direction of force (PDOF) and a (B)ack damage code are included in the BDC. Back Damage Crashes include 1 at 5 o'clock, 58 at 6 o'clock and 1 at 7 o'clock. OSI crashes include 44 at 6 o'clock and 1 at 7 o'clock. The distribution of back damage lateral location is shown in Table 1. The most common back damage locations are (D)istributed, involving direct contact to all thirds of the rear, (19 BDC and 15 OSI) and (Y) the left two thirds (14 BDC and 13 OSI). The distribution of damage extent is shown in Table 2 and the cumulative frequency of the known damage extent for the two populations is shown in Figure 2.

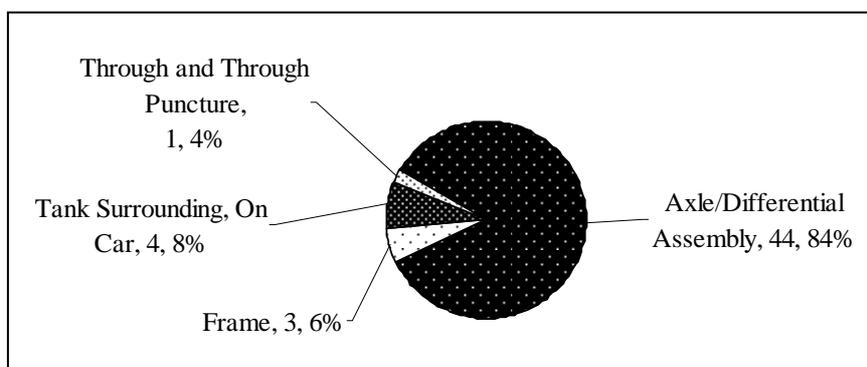
Figure 3, Assembly/Mechanism of (F)ront Failures

Distribution by location of failure for the (F)ront area and (B)ack area of the fuel tank is shown in figure 3. Most failure locations are at the bottom half of the fuel tank because interference between the tank and axle biased to the bottom of the fuel tank and the load path from objects in the trunk of the vehicle is biased lower. Failures to the back of the tank are more distributed and less bias to the bottom half when compared to the distribution of failures to the front of the fuel tank. Failures to the front of the fuel tank are dominated by crash induced deformation and crushing due to tank to axle/differential interaction.

The distribution by assembly/mechanism induced failure for the (F)ront area and (B)ack area of the fuel tank are shown in figure 3. For the (F)ront area it is notable that 44 (84%) failures are caused by the axle/differential assembly. Five distinct components of the axle/differential assembly are classified as causing punctures of the fuel tank. The distinct axle/differential components with an accompanying count of failures per component are: six (6) by the parking brake cable mounting bolt, 13 by the shock absorber mounting bracket, seven (7) by the sway bar mounting bracket, seven (7) by the coil spring seat, lower mount, seven (7) by the differential rear cover and five (4) not specified on the axle/differential assembly. To the (B)ack area most failures are due to trunk equipment, four (4) by mounted trunk equipment, eight (8) by non-mounted trunk equipment, and two (2) by not specified trunk equipment. Seven (7) failures to the (B)ack area are from deforming vehicle components including aspects of the fuel tank strap mount and deforming metal.

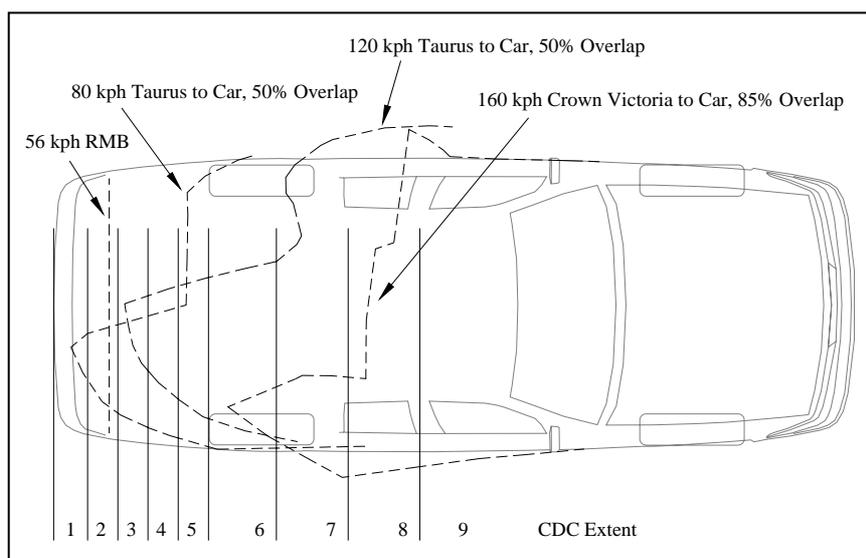
Figure 4, CDC Damage Extent and Typical Crash Test Damage

Crash testing used by Ford in the development and presumed validation of the CVPI prior to 2002 included RMB testing at 48 kph and 56 kph and Taurus-to-car testing at 80 kph with complete overlap and 50% overlap. Referencing figure 5, an 80 kph, and 50% overlap test produces a CDC damage extent of five (5), or severity at the 24th percentile, for the population of CVPI OSI crashes in this study. Although some crash test induced incipient failures are observed, most of the failures demonstrated in the investigation of real world crashes did not occur in crash testing.

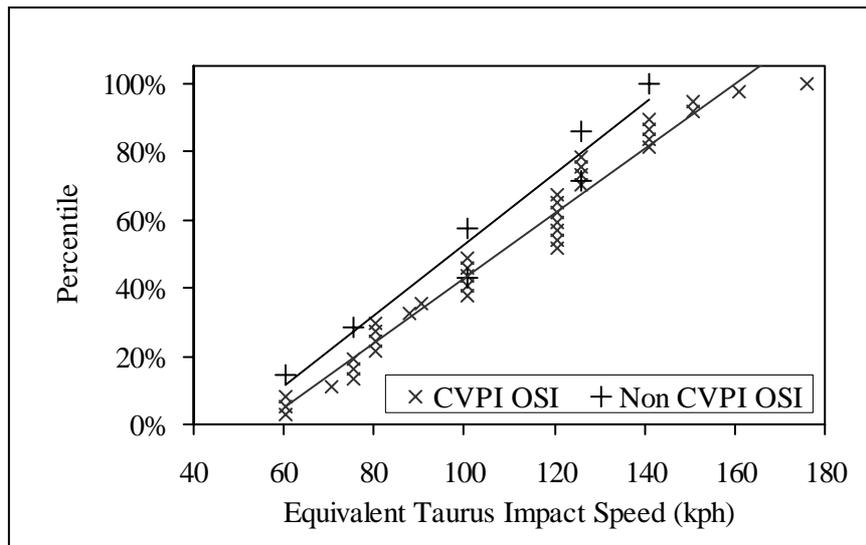
Figure 5, Cumulative Frequency of Equivalent Taurus Speed

Numerous controlled rear impact crash test have been conducted on the CVPI including: 48 kph Rear Moving Barrier (RMB) (FMVSS Compliance); 56 kph RMB (NCAP); 80 kph, 50% overlap Taurus-to-car; 80 kph, full overlap Taurus-to-car; 80 mph 70% overlap Deforming (D)RMB (approximated update to FMVSS start effective date MY 2007); 120 kph, 50% overlap Taurus-to-car and 160 kph, 85% overlap Crown Victoria-to-car. Typical post crash rear bumper profiles and CDC damage extent regions are overlaid onto an undamaged vehicle in Figure 4. Because a standardized rear impact test of police vehicles utilized a Ford Taurus sedan impacting at 120 kph with a 50% overlap, a speed versus damage characterization is developed using the 80 kph and 120 kph, 50% overlap tests and the 160 kph test. An equivalent Taurus speed in the 160 mph Crown Victoria-to-car test, assuming constant vehicle properties, is calculated at 175 kph. Damage area and extent are coded for the crash tested vehicles using the CDC protocols. Applying the damage area equivalent speed characterization to the crash populations CVPI OSI and non-CVPI OSI yields the distribution of speeds shown in figure 5. The 50th percentile speed is 97 kph for non-CVPI OSI and is 107 kph for CVPI OSI.

2. For studied rear impact crashes with fuel leakage or fire equivalent Taurus rear impact speed ranging from 60 kph to 176 kph cause failure in CVPI fuel containment systems. Crashes from the entire range of impact speed should be included in analyses. The 50th percentile, 85th percentile speed is 107 kph and 144 kph, respectively.

1. For rear impact crashes studied resulting in fuel tank leakage or fire, rear impact damage and corresponding equivalent Taurus rear impact speed is greater than for identical vehicles in civilian use. Vehicles sold for police use require a higher speed validation crash test for fuel system integrity. A 120 kph Taurus (or equivalent) to car 50% overlap test with police equipment placed as cargo in the trunk is presently the standard used in police car fuel containment system validation.
